# Governor Warner Mansion Assessment Report

City of Farmington

DRAFT REPORT: AUGUST 17, 2020

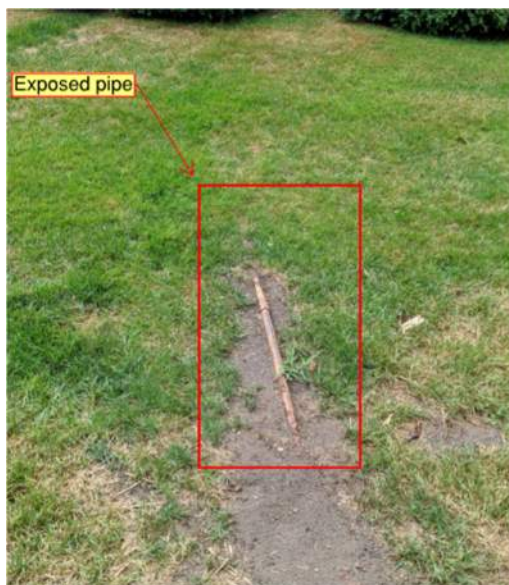
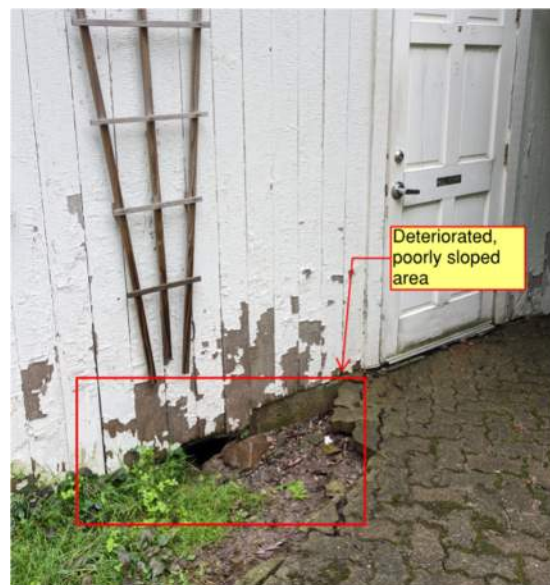
- 1.1 Exposed pipe: An exposed pipe was observed on the eastern side of the property. The pipe poses a tripping hazard and can also be damaged due to it being exposed. Recommendation: Inspect and rebury pipe. **Priority: Short-Term**
- 1.2 Deteriorated area on west side of mansion: A deteriorated area was observed on the western rear of the mansion near the Carriage House. The grade in this area is sloped toward the house, with an exposed opening leading to the crawl space for water to enter. Recommendation: Remove pavers, infill foundation and repair boards, provide sand infill subgrade and replace with new brick pavers. **Priority: Short-Term**

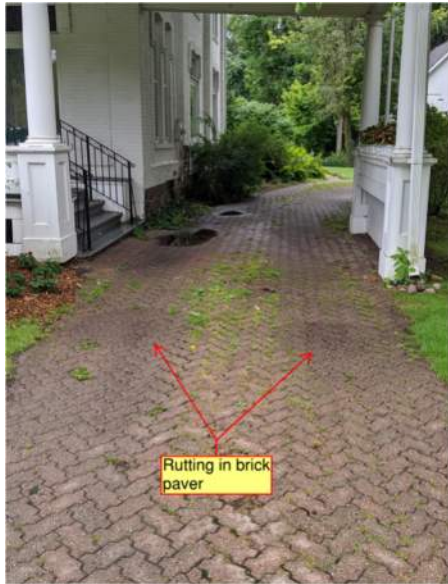
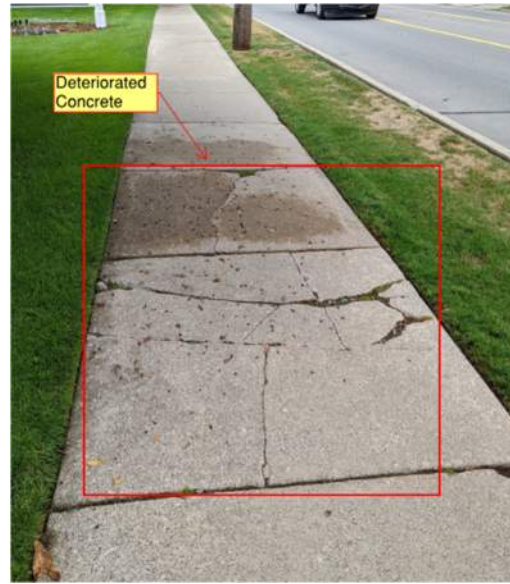
- 1.3 Rutting in brick pavers: Rutting observed in the brick paver drive on the west side of the mansion. This is likely due to vehicles parking or passing through frequently. Recommendation: Remove pavers, provide new subgrade consisting of aggregate base, sand setting bed and replace with new brick pavers. **Priority: Mid-Term**
- 1.4 Deteriorated Concrete Walk: Two slabs in the concrete sidewalk along Grand River Avenue are deteriorated and beginning to break off. Recommendation: Saw cut and remove deteriorated slab, and provide new 4" concrete sidewalk slab in place. **Priority: Short-Term**

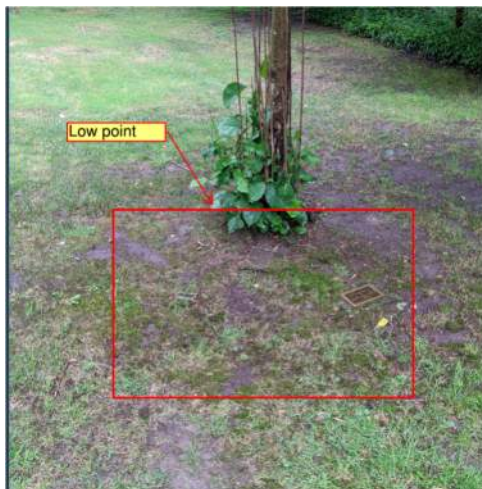
1.5 Low Point in front of memorial: A low point was observed in front of the tree memorial. The low point could be a possible tripping hazard. Recommendation: infill with additional soil. **Priority: Mid-Term**

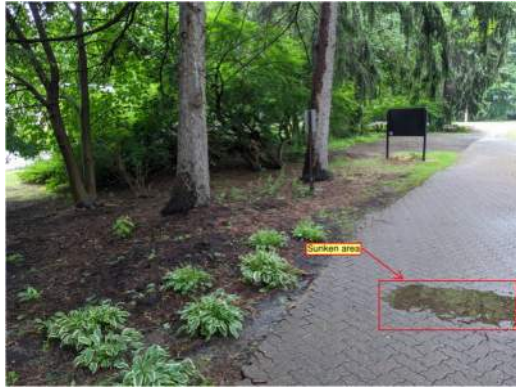
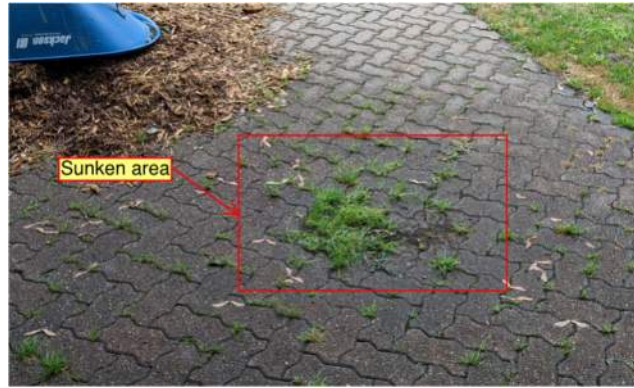
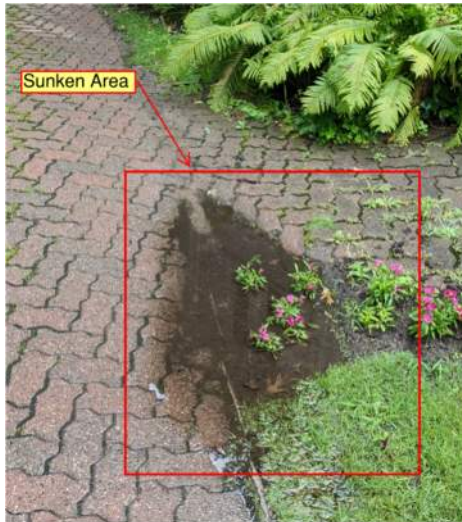
1.6 Sunken Brick Paver Areas: Sunken brick paver areas were observed in the drive on the west side of the mansion. These depressions are areas where water has begun to pool, which will likely result in further deterioration. Recommendation: Remove pavers, provide new subgrade consisting of aggregate base, sand setting bed and replace with new brick pavers, blending in with surrounding existing pavers as feasibly possible. **Priority: Long-Term**

The following photos depict the damage:

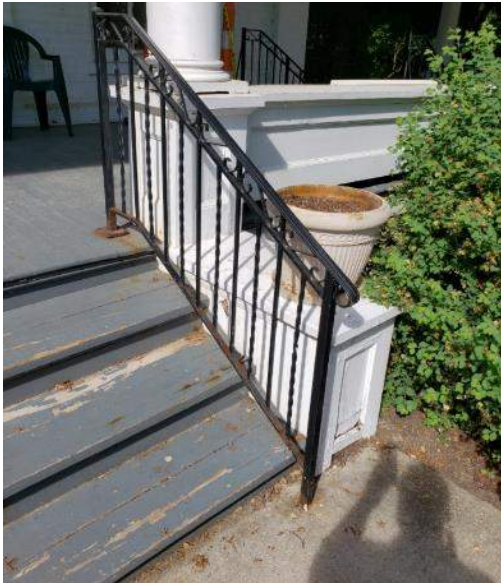
- 2.1 Front (North) Porch Stair - the right side of the wood stair base presents minor wood rot and failed trim, and the steel handrail is corroded. Recommendation: Remove and replace the wood sections in kind with pressure-treated lumber and galvanized fasteners. Paint the repair to match existing surrounding. Wire brush the handrail to remove rust and repair the rail using similar stock material. Paint the rail with a rust-inhibitive epoxy, color to match existing. **Priority: Short Term.**

*Rusted railing, wood sections rotted/failing, repair/paint.*

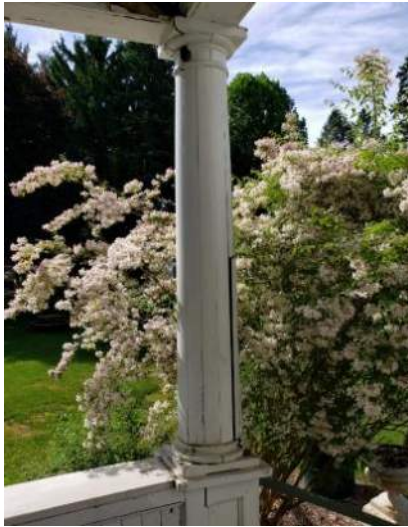
- 2.2 East Porch Column - This wood column presents two failures. First, the column base has settled, forcing the column to rotate down and out from the building. Observations without excavation here were limited, but the column base appeared to be set on a thin concrete pad rather than a footing. The shift has separated the many pieces of the wood column and forced it out of plumb allowing stair treads to settle out of level. Second, the top of the column has two holes and resulting wood rot from bird infestation. Recommendation: Remove and rebuild the column. Replace the failed or rotted components with like sections and materials. Remove the concrete pad and place a 12-inch sonotube concrete pier to 48" below grade for support of the repaired column. Repair the stair to a level condition, replace damaged stair structure, and repaint to match surrounding finishes. **Priority: Short Term**

*Column failure*

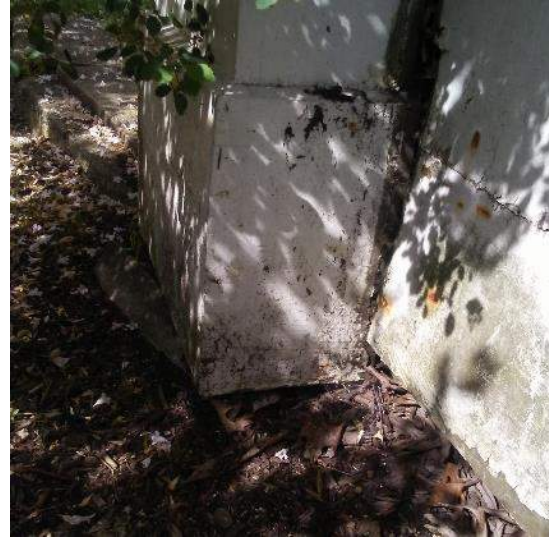
*Foundation unknown, concrete pad only visible*

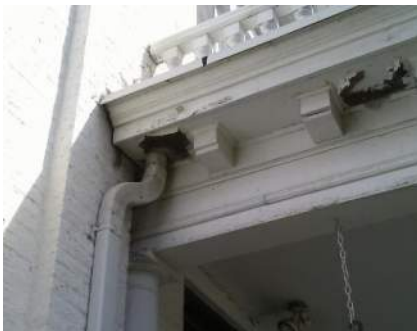
2.3 East Porch Soffit - The wood soffit shows signs of water damage and some wood rot near the downspout. Recommendation: Remove and replace failed soffit with pressure-treated lumber of like sections and paint to match. Coordinate roof above sealant and flashing repairs with this repair. **Priority: Mid-Term.**

*Soffit repair, clean, replace rotted wood*

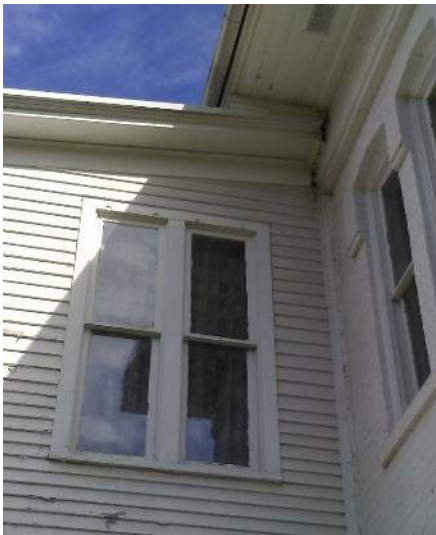
2.4 Addition Settlement and Separation - Work performed on the addition following the previous inspection in 2015 sought to stabilize the 1906 foundation against frost heave and settlement, but did not address the movements or separation between the two structures. This inspection found the original 1867 north footing and basement wall to be intact and without movement. Movement of the 1906 addition separated the addition from the original north brick face by approximately 2 inches at the top of the addition and warped the north brick wall out of plumb. This caused the second floor to slope away from the original building, force walls and doorways out of plumb and square, and create a gap at the interface of the addition with the original wall. These gaps are large and open to outside air and could result in varmint infestation. The gaps further indicate that the addition walls have lost any lateral support from connections with the brick wall. Recommendation: The following work should be performed by an experienced historical restoration contractor. Sever any remaining connectors between the building addition walls and the original brick north wall, and release anchors between the addition sill plate and foundations. Excavate as required to expose the addition wood frame base and hydraulically jack the frame back to a level, plumb, and square condition. Grout fill foundation gaps and reattach the addition walls to the original brick face. Any architectural finishes at the interface of the two buildings can then be repaired to original condition.

*Exterior Gap*

**2.4a Jacking and subsequent repairs: Mid-term**

**2.4b Sealing and repair of described gaps: Short Term**

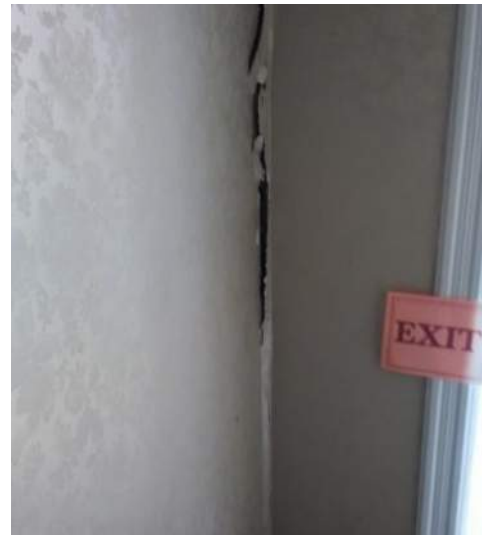
*Interior Gap*

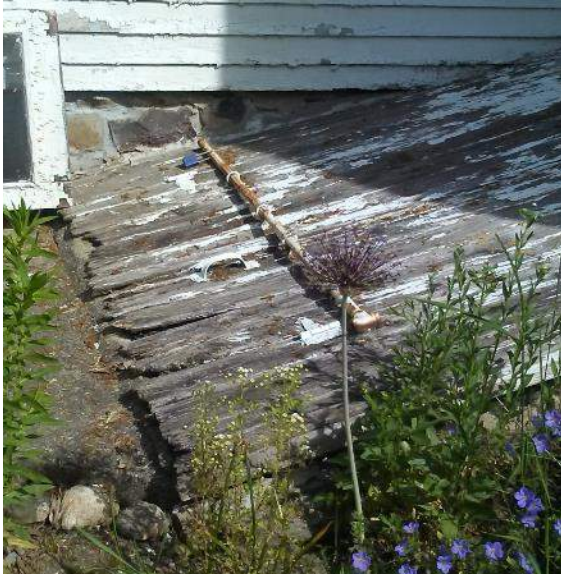
2.5 Basement Hatch - The original wood basement hatch has rotted and deteriorated to failure. Indications are that the hatch is no longer used (the stair to the basement is intact but the interior door did not open), this hatch may fail under standing weight. Recommendation: remove and replace the door with painted wood similar to existing. **Priority: Short Term**

*Basement Hatch*

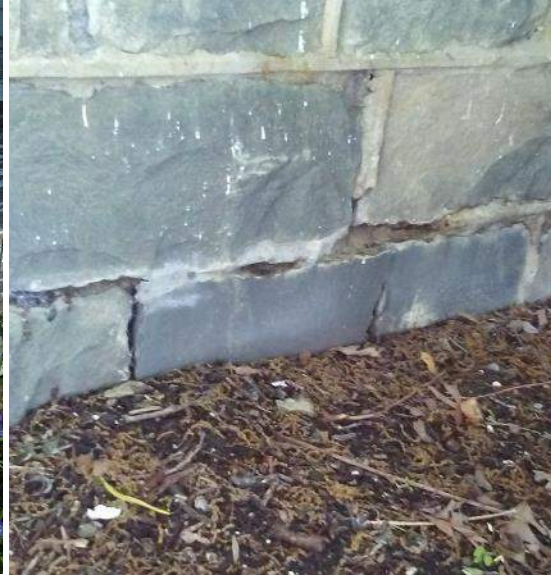
2.6 Stone Wall Joints -Basement walls consist of mortared stone. Observation found most visible walls to be intact and in good condition. Two minor joint failures were observed, at the south wall gardener entry and midway along the west wall. Recommendation: tool and mortar the joints. **Priority: Short Term**

*Foundation mortar repair*

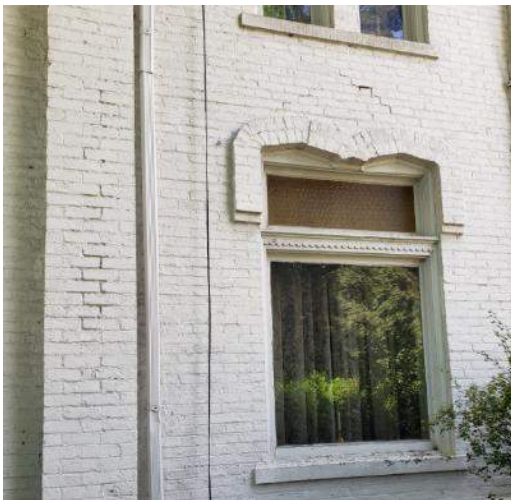
- 2.7 Brick Chimneys – The two east side brick chimneys that project from the roof show signs of masonry joint failure. The north chimney has both joint and brick failure at the chimney cap. Recommendation: tuck point both chimneys and replace the top portion of the north chimney with new brick (attempt to match existing brick texture and color). **Priority: Short Term**
- 2.8 Brick Joints – Brick faces of the original building were painted and in general didn't show any signs of failures to brick or brick mortar joints. One failed mortar joint was observed on the building east side at second floor. Recommendation: point the failed joint and have a mason inspect the remainder of the brick faces for further joint repair. **Priority: Mid-Term**

*Tuckpointing/brick repair*

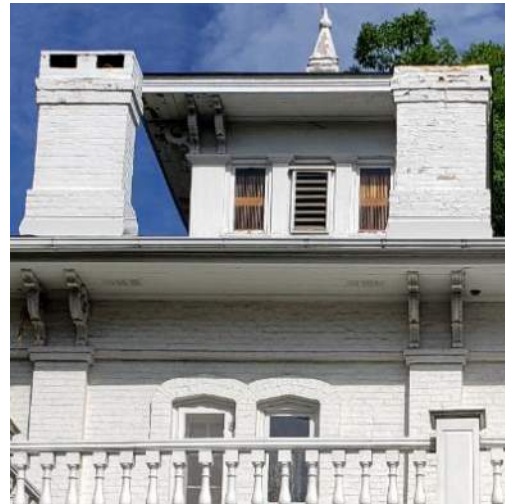
*Chimney repair*

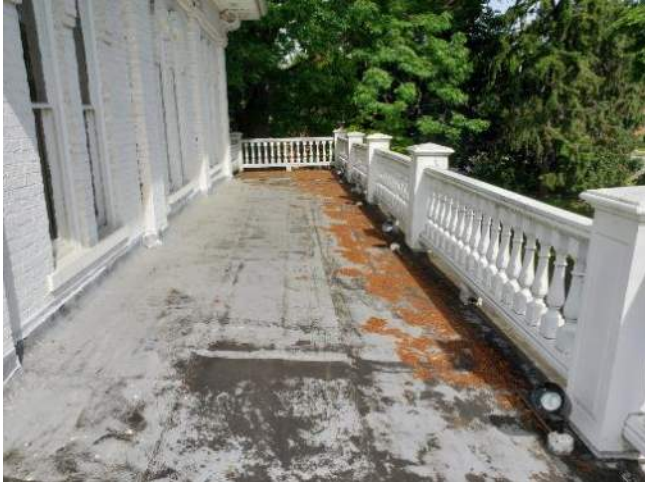
2.9b. Porch Roof: Built-up roof system on porch shows wear and failure of sealant and flashings at balustrade posts. Recommendation: Replace sealants/flashings as part of regular roof inspection and maintenance program as necessary. Recommend raising electrical conduit off of roof as well. Plan for replacement of roof mid-term **Priority: Mid term.**

*Porch roof, raise electrical conduit*

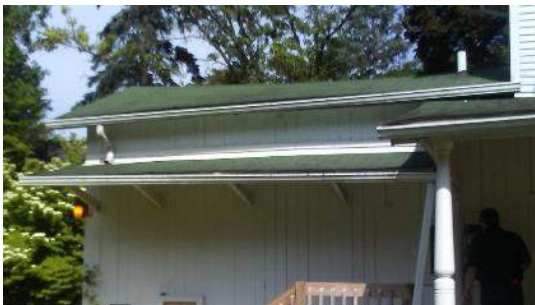
2.9c Addition Roofing and Sheathing – Shingled: Roofing is conventional 3-tab asphalt shingle and appears worn. Roof sheathing consists of 1” thick plank. This sheathing presents some deflection but is intact. Recommendation: remove and replace the shingles with a new vapor barrier and a typical 25-year 3-tab asphalt shingle. **Priority: Mid-term**

*Replace shingled roof*

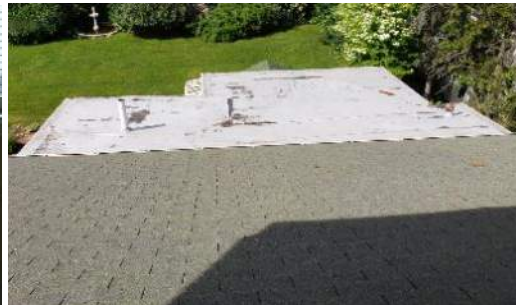
2.9d Addition roofing – low slope: Additionally the built-up membrane roof appears worn and should be evaluated by roofing contractor. Recommendation: Replace roof with replacement of the above-mentioned shingled roof. **Priority: Mid-term**

*Replace membrane roof.*

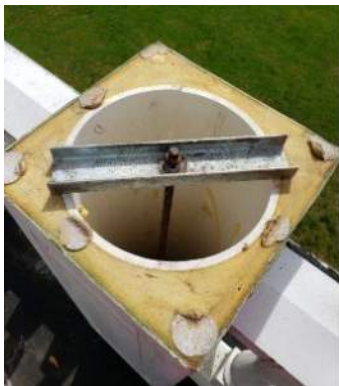
2.10 Porch Roof Balustrade: The balustrade appears in good condition; one cap was loose and should be glued back down. Recommendation: Clean the balustrade to remove surface blemishes and repair any loose fittings. **Priority: Short Term**

*Repair loose caps*

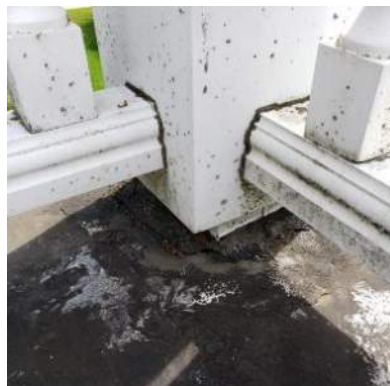
*Miscellaneous flashing repairs, clean PVC panels.*

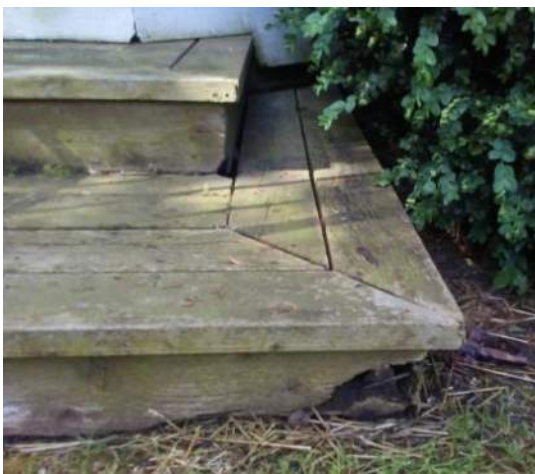
2.20 Stairs - the Gazebo wood stair shows signs of local wood rot at its east end at grade. Recommendation: Remove the failed riser and replace with a pressure-treated like section. **Priority: Short term**

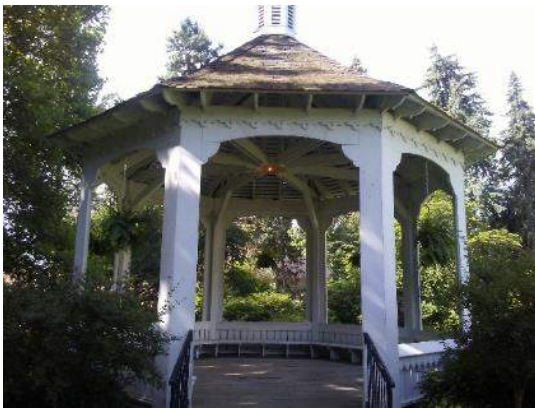
2.21 Roofing – the Gazebo roofing consists of cedar shake shingles. The shingles are weathered, moss-covered, and exposed edges have deteriorated. The roof frame appears intact. Recommendation: replace the shingles with like material and size. **Priority: Mid-term**

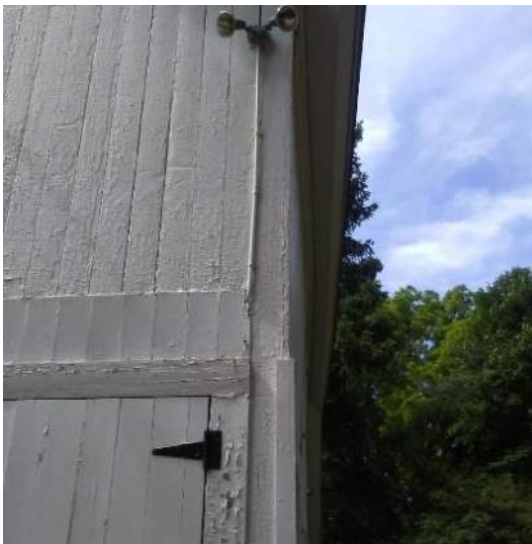
2.30 Exterior painting is showing wear and has some areas that are starting to peel. Recommendation: Prepare and paint area that show wear as part of on-going maintenance for the building. Priority: Mid-term

*Picture of carriage house paint siding showing wear*

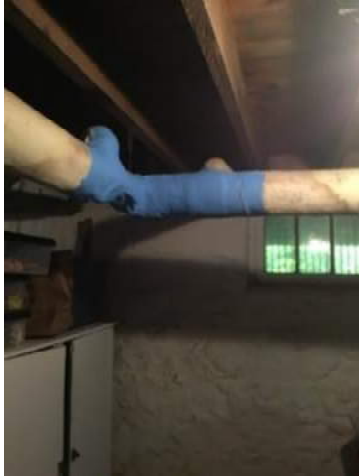
3.1 Due to the age and construction, lead paint would be expected to be encountered within the paint layer profile. Care should be taken when any sanding or scraping of painted surfaces is completed. Based on visual inspection only, insulation on steam piping in the lower level outside the renovated mechanical room insulation material is presumed asbestos-containing material due to its age and appearance. It is recommended to have a sample tested. If positive for asbestos fibers it is recommended at a minimum that the insulation be labeled as such or abated by a licensed contractor.

*Steam piping - example of possible asbestos insulation*

Recommendation: Acquire lead and asbestos testing from certified firm for entire facility for use and reference on future work; Develop plan for remediation of found items.

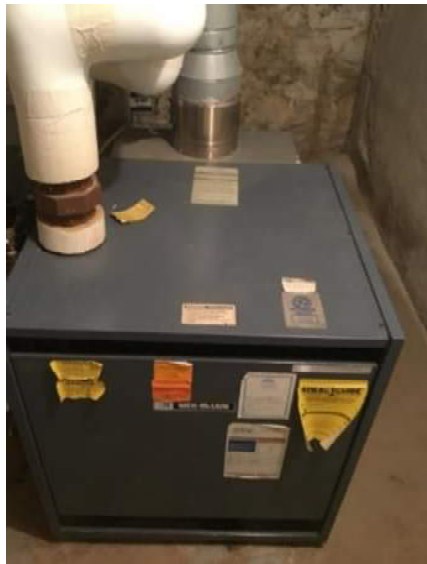
4.1 The main residence is heated with a gas-fired steam boiler. The boiler was replaced in 1999 and has a capacity of 203,000 btu/hr. The boiler uses an automatic damper and draft inductor for the flue. Both appeared to be in good operation. Michigan Boiler Division Rules; Rule 27 requires safeties on the boiler be inspected by a certified contractor yearly to obtain a boiler permit. There is no evidence of this CSD-1 inspection with a current date. The boiler permit is currently expired and must be made current. Recommendation: Re-certify permit. **Priority: Short Term**

4.2 Due to service life, the replacement of the boiler should be completed in the next 10 years. **Priority Mid-term.**

*Steam Boiler*

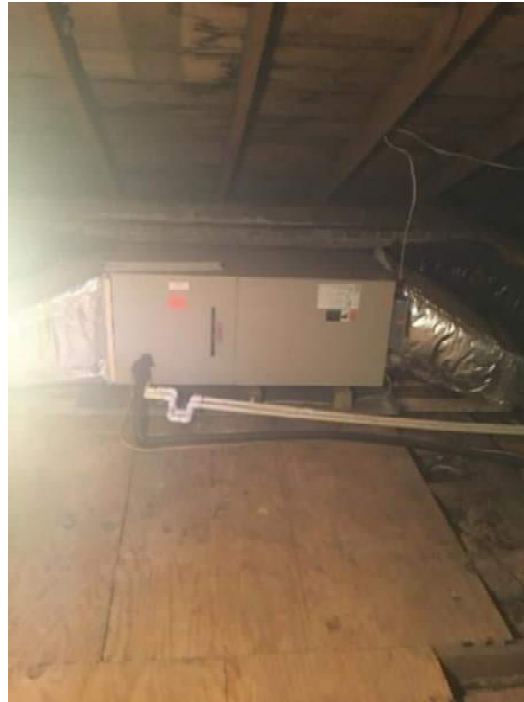
*AC evaporator and fan in attic*

The second floor attic has an air conditioning unit serving the second floor only. The lineset is run through a downspout for concealment and the lineset is rubbing on the downspout. This will soon cause a hole and leak. The insulation has degraded resulting in a loss of efficiency. The unit uses refrigerant (R-22) that is rapidly being phased out due to environmental risks. This refrigerant is quickly rising in cost and therefore any leaks will be costly to fix. It is recommended that a bushing be added to stop abrasion to the lineset and insulation repaired. Replacement of the current unit is also recommended due to obsolete refrigerant.

4.4: Recommendation: AC unit replacement including condenser: **Priority: Mid-term**

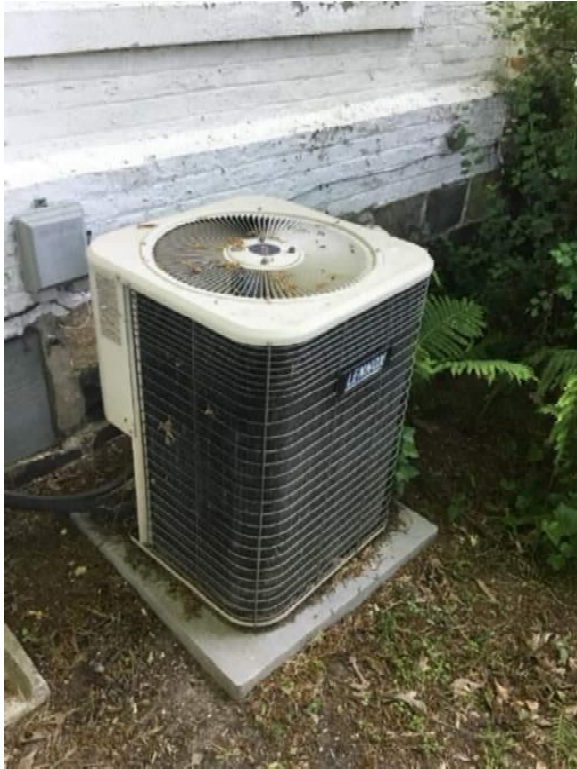
Condenser

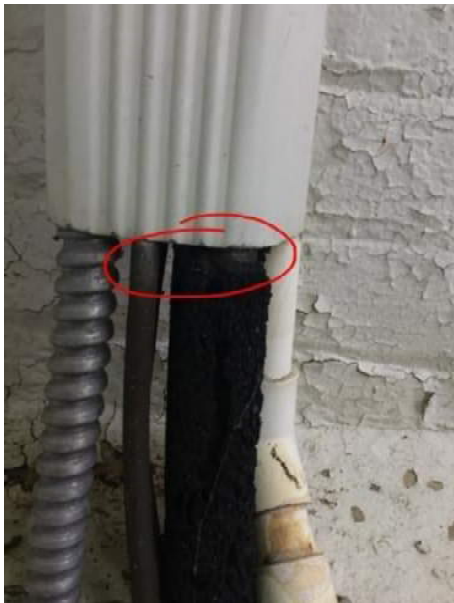
Refrigerant line set rubbing

4.3: Recommendation: AC Line-set Repairs: **Priority: short term**

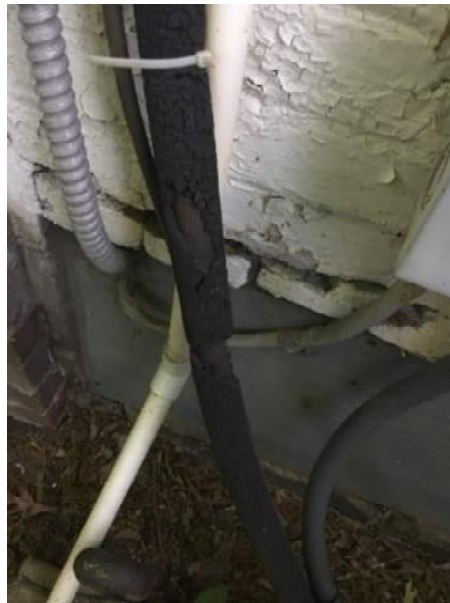
Degraded Refrigerant Line set Insulation

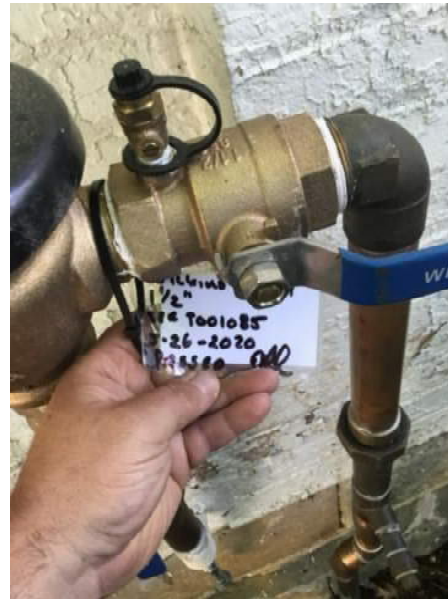
4.5 The domestic water service has been upgraded from galvanized to copper pipe. The internal domestic water distribution piping is also copper. The sanitary waste piping is cast iron. Both systems visually appear to be in good condition. Irrigation on the property exists and is isolated from the domestic water system by a backflow preventor. The inspection and testing on the backflow device is current. Recommendation: Backflow inspection needs to be completed annually.  
**Priority: Short term**

*Backflow inspection*

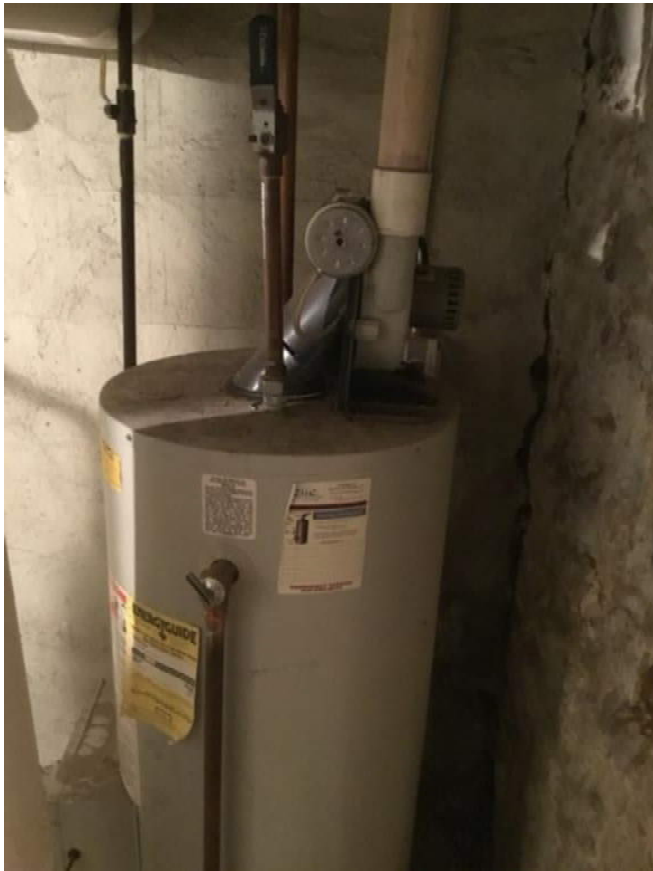
4.6 Domestic water is heated by a gas-fired power vent water heater. The unit is a 38 gallon, 40,000 btu/hr tank style model. This heater appears to be the same vintage as the boiler. Recommendation: Replace water heater in the next 5 years due to service life. **Priority: Mid-term.**

*Gas fired water heater*

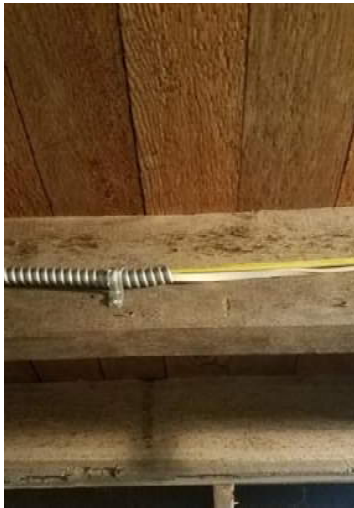
*Example of inappropriate wiring found in basement*

5.1: Recommendation: Rewire basement wiring; **Priority: Short Term**

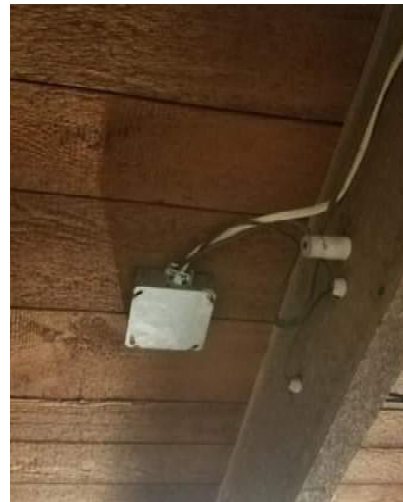
*Example of inappropriate wiring found in basement*

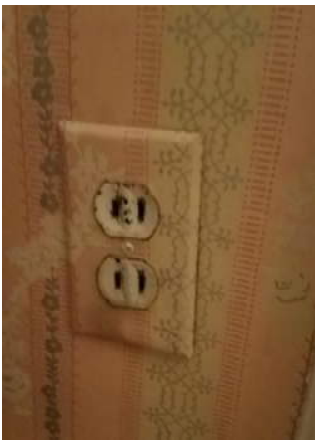
*ungrounded receptacle – second floor bedroom*

5.2: Recommendation: Install grounded receptacles; **Priority: Short Term**

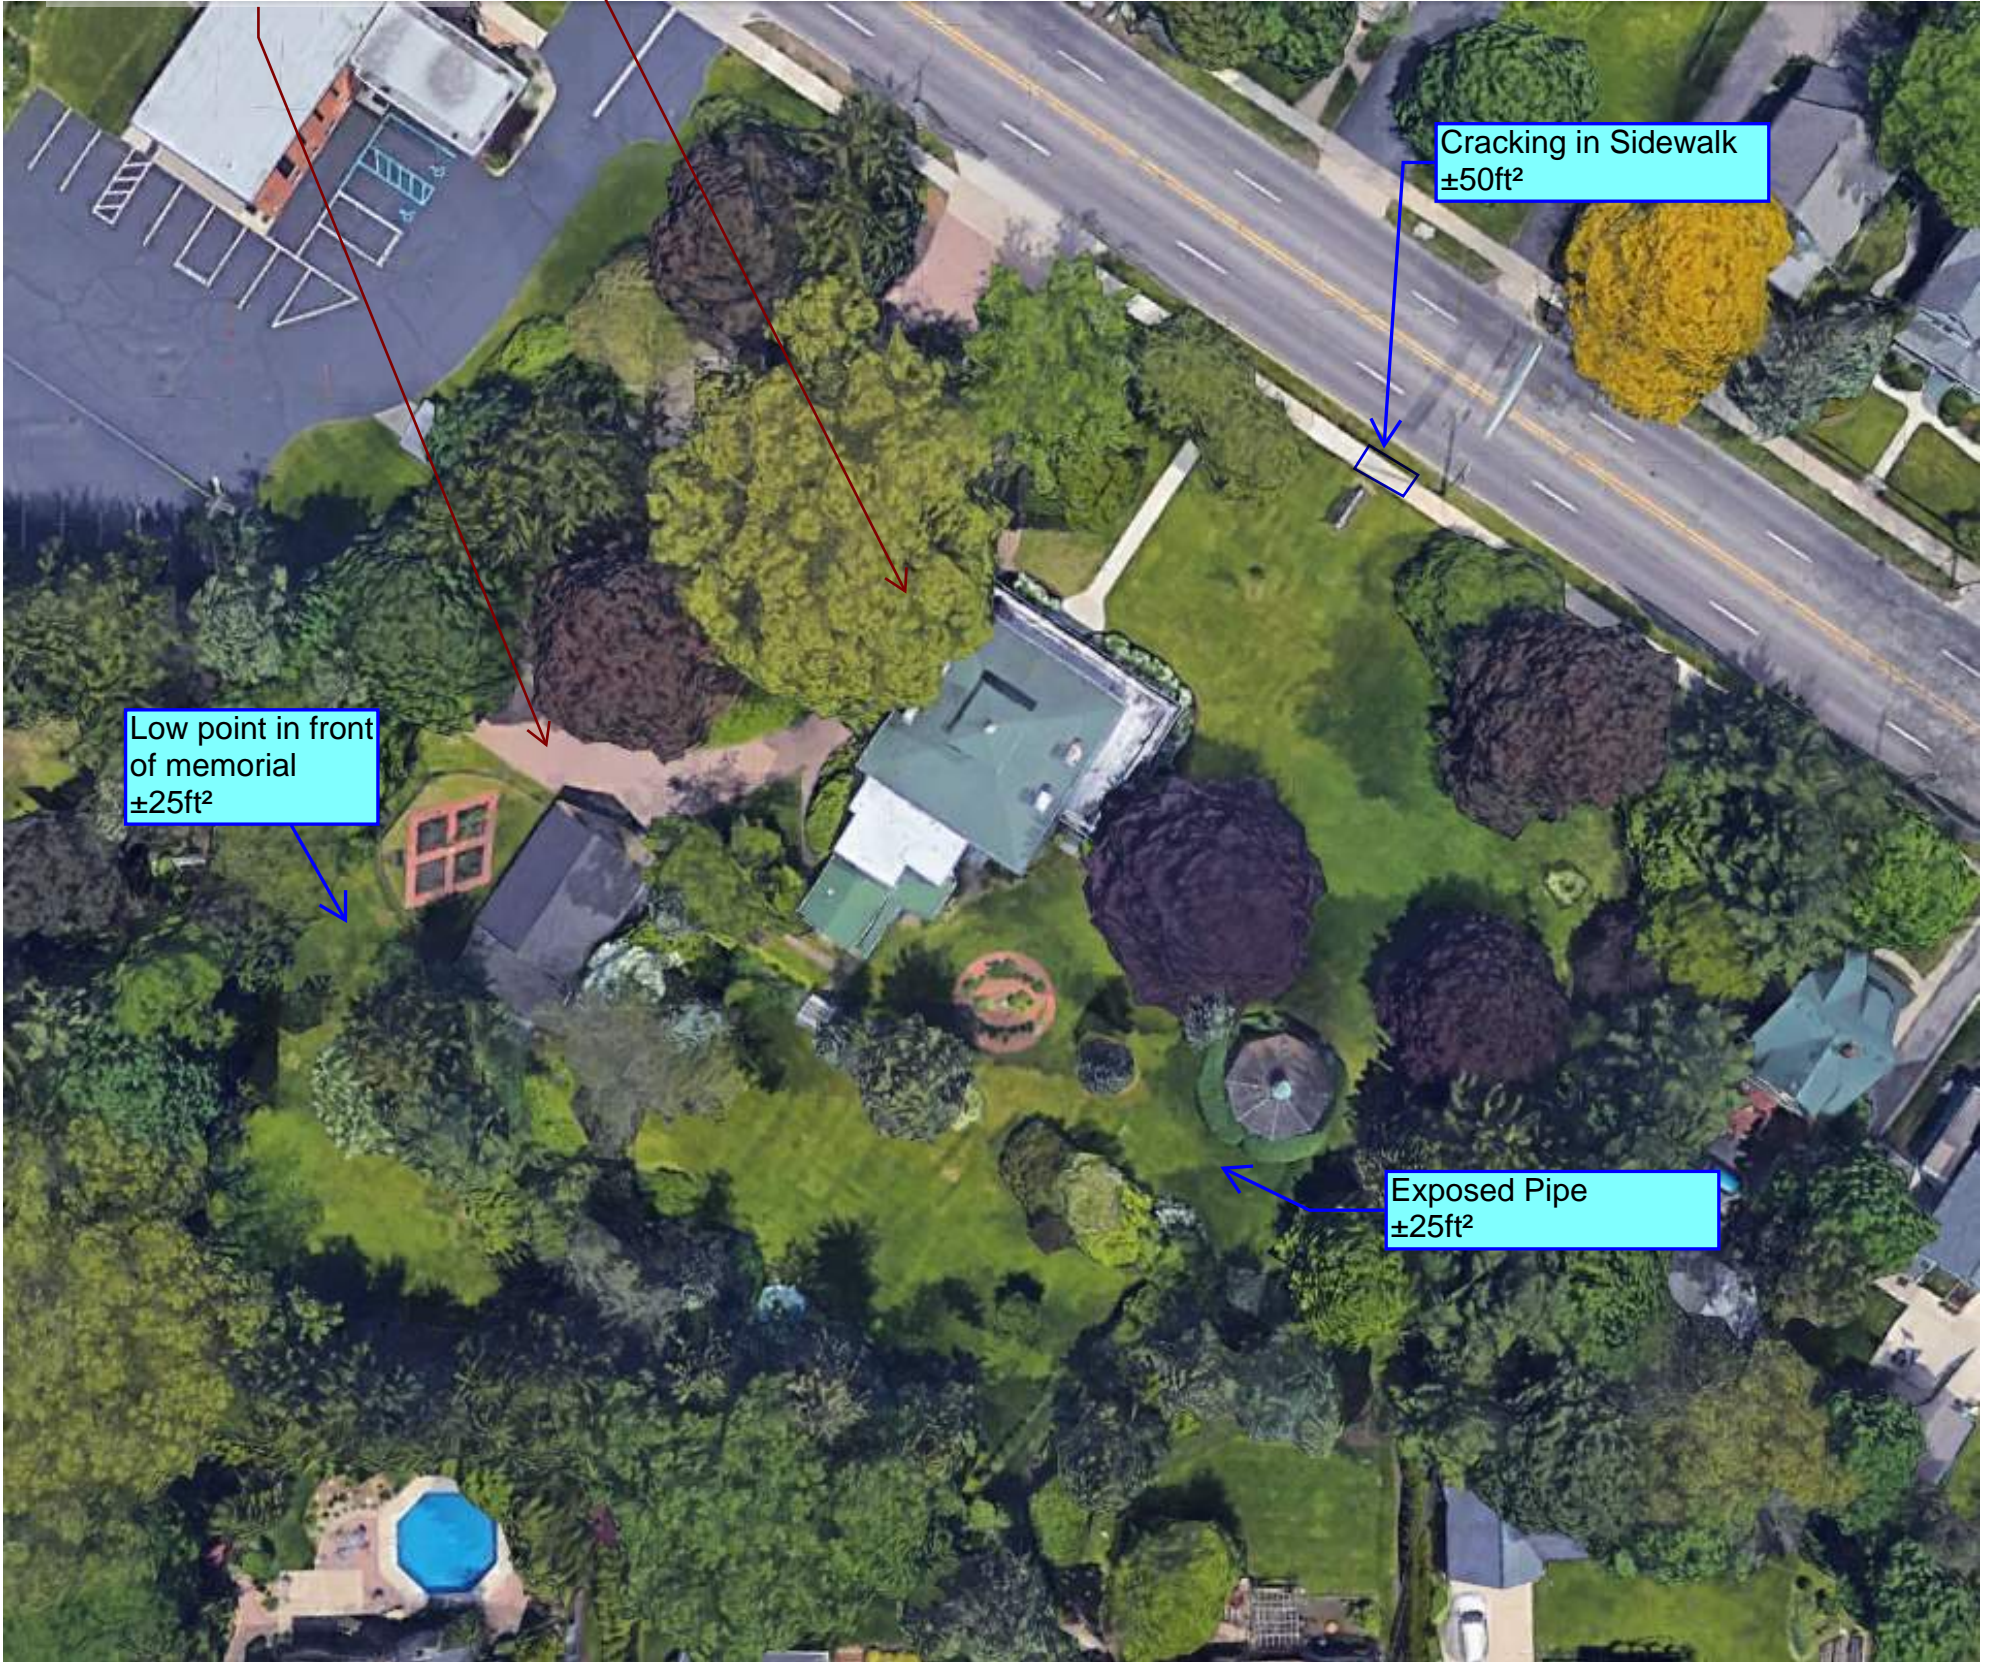
RUTTS IN DRIVEWAY AT CANOPY ±800ft<sup>2</sup>

SUNKEN AREAS IN DRIVEWAY, 3 LOCATIONS ±75ft<sup>2</sup>
